Issue with the Spectra

Due to this, the spectra and hence moments files will be having some issue after the replacement of the new antenna i.e, 23.08.2023 to 18.09.2023

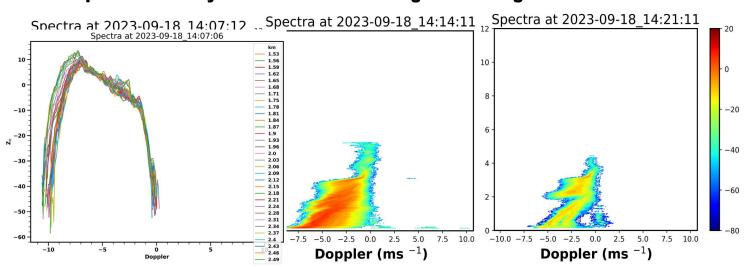
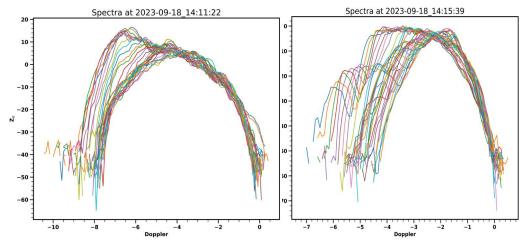
- side lobes in the higher heights
- distorted above 2.12 km

Spectral density after the above settings are changed

• switching off the Half-overlapping
